Name Of Dam: GENT BROTHERS DAM  
Location: RUSSELL COUNTY, VIRGINIA  
Inventory Number: VA. NO. 16706

# PHASE I INSPECTION REPORT

## NATIONAL DAM SAFETY PROGRAM

SCHNABEL ENGINEERING ASSOCIATES, P.C./  
J. K. TIMMONS AND ASSOCIATES, INC.

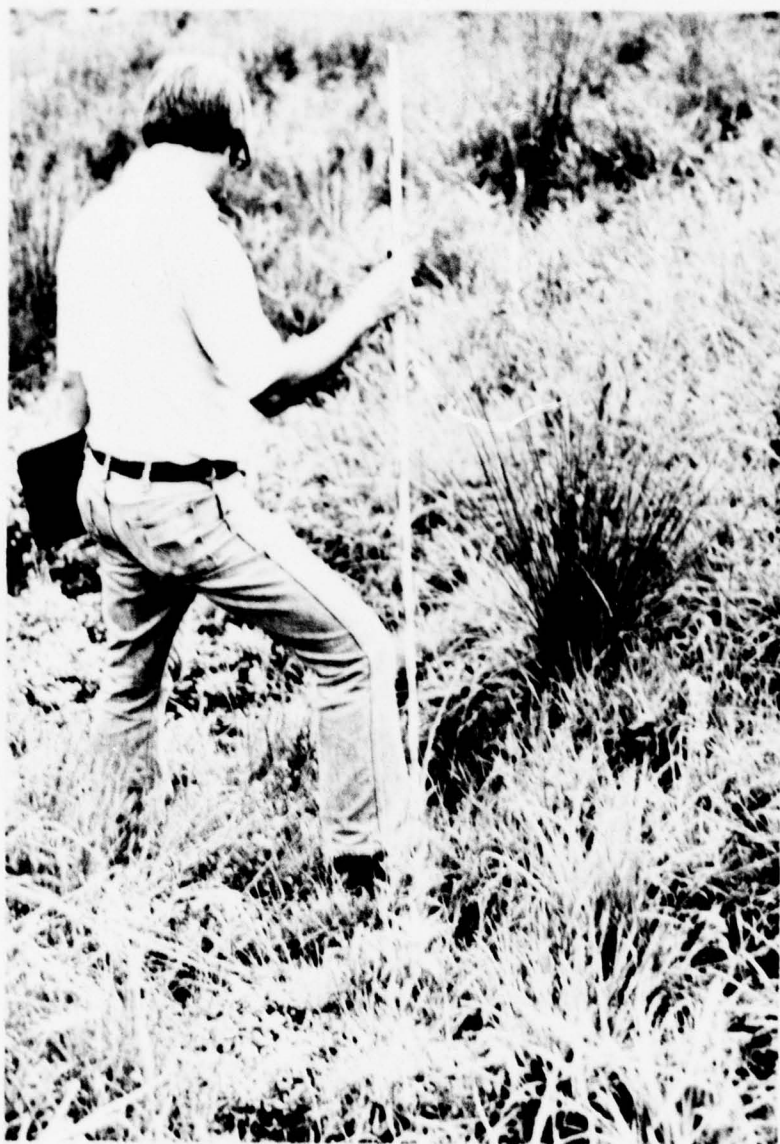
Wet areas caused by discharge from toe drains occur beside and beneath the principal spillway pipe. Seepage existed along the base of the downstream toe of the right abutment and two seeps were observed about 40 ft to the right of the intersection of the right abutment and the face of the dam. Flow was clear and generally less than 2 gpm. Minor iron-staining was encountered at a few locations, roughly midway between the seeps and the principal spillway. The Owner stated that these seeps are actually springs, which were present prior to construction of the dam.

The seep present at the toe of the downstream slope at the right abutment may actually be a spring; however, this was not definitely confirmed. It is recommended that this area be monitored quarterly to detect any increase in flow rates and erosion. The two wet areas located 40 ft<sup>±</sup> to the right do appear to be springs, and they should also be monitored quarterly to detect any increase in flow rate and erosion.

VIEW OF SPRING LOCATED ALONG BASE OF RIGHT ABUTMENT

7.4.1 The seep present at the toe of the downstream slope at the right abutment may actually be a spring; however, this was not definitely confirmed. We would recommend that this area be monitored quarterly to detect any increase in flow rates or erosion. The two wet areas located 40 ft<sup>±</sup> to the right appear to be springs. They should also be monitored to detect any increase in flow rate.

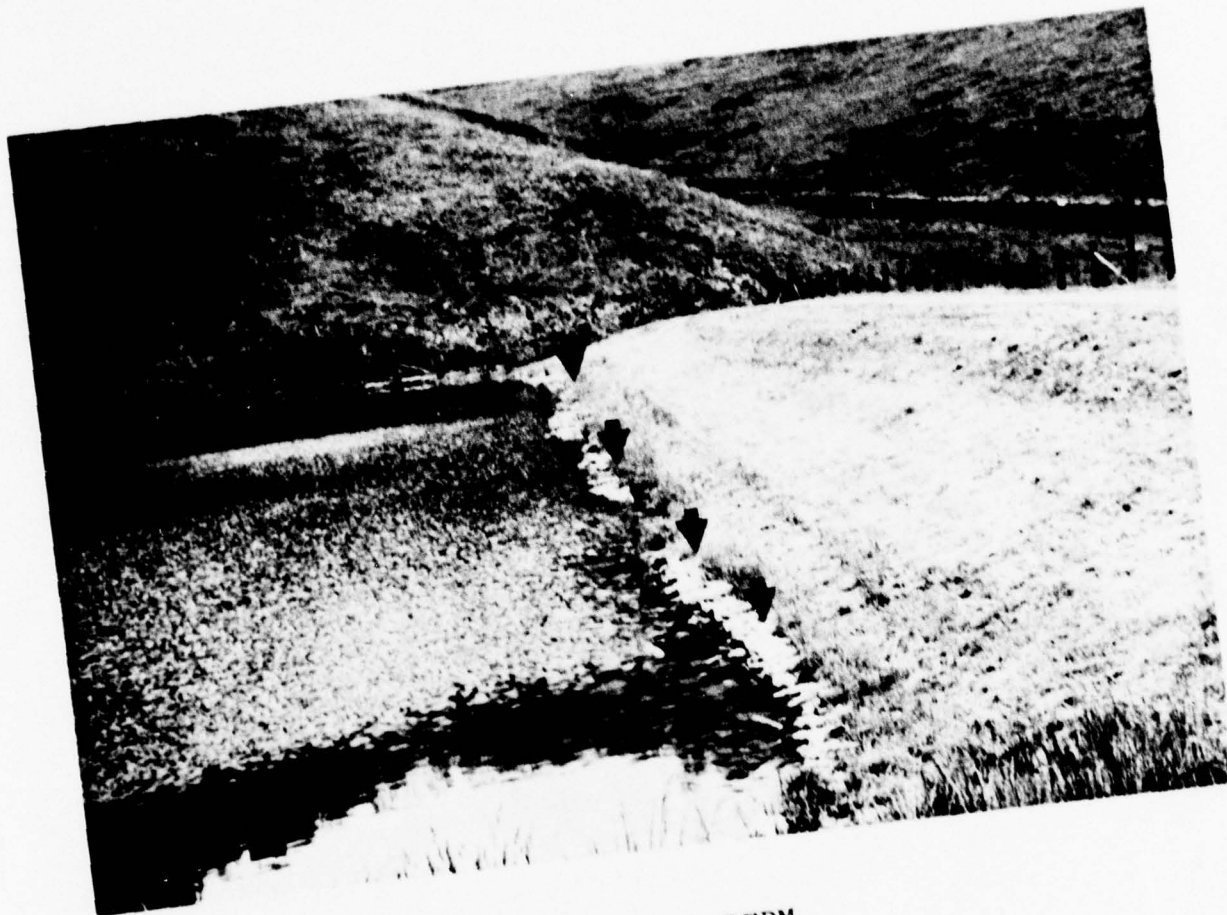
VIEW ACROSS UPSTREAM FACE OF BERM  
(Note Intake and Rip Rap)

1.5 Riprap: Showed no displacement or washing; appeared to be in proper alignment and in good condition. Blocks of rock ranged from 0.5 to 3 ft<sup>±</sup> in length and were reportedly hand placed.

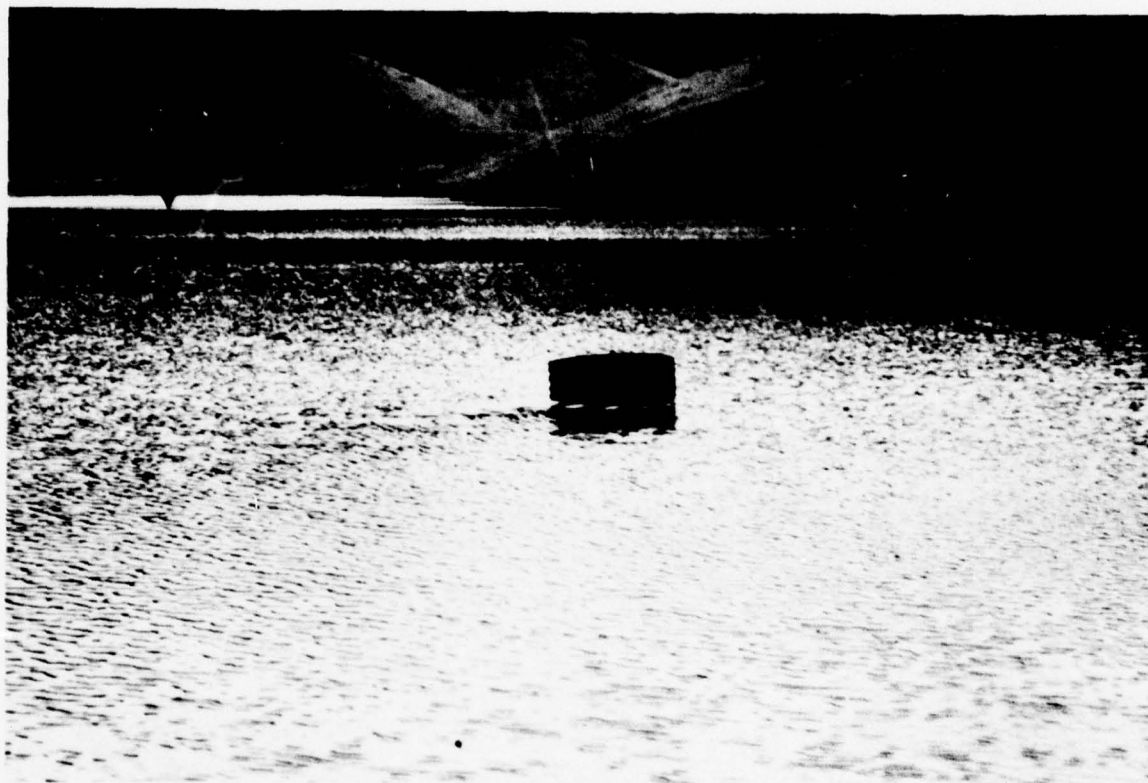
The principal spillway intake and discharge pipe are in good condition. No debris was noted on the inlet. The 8"

gate was reportedly in operating condition. The principal spillway is an 18" bituminous coated CMP with a 24" CMP riser. The emergency spillway was in good condition.

VIEW OF RISER INTAKE  
(Note 8" Gate Location with Arrow. Also, Headwater Spring  
Locations in Background at Location of Cattle)

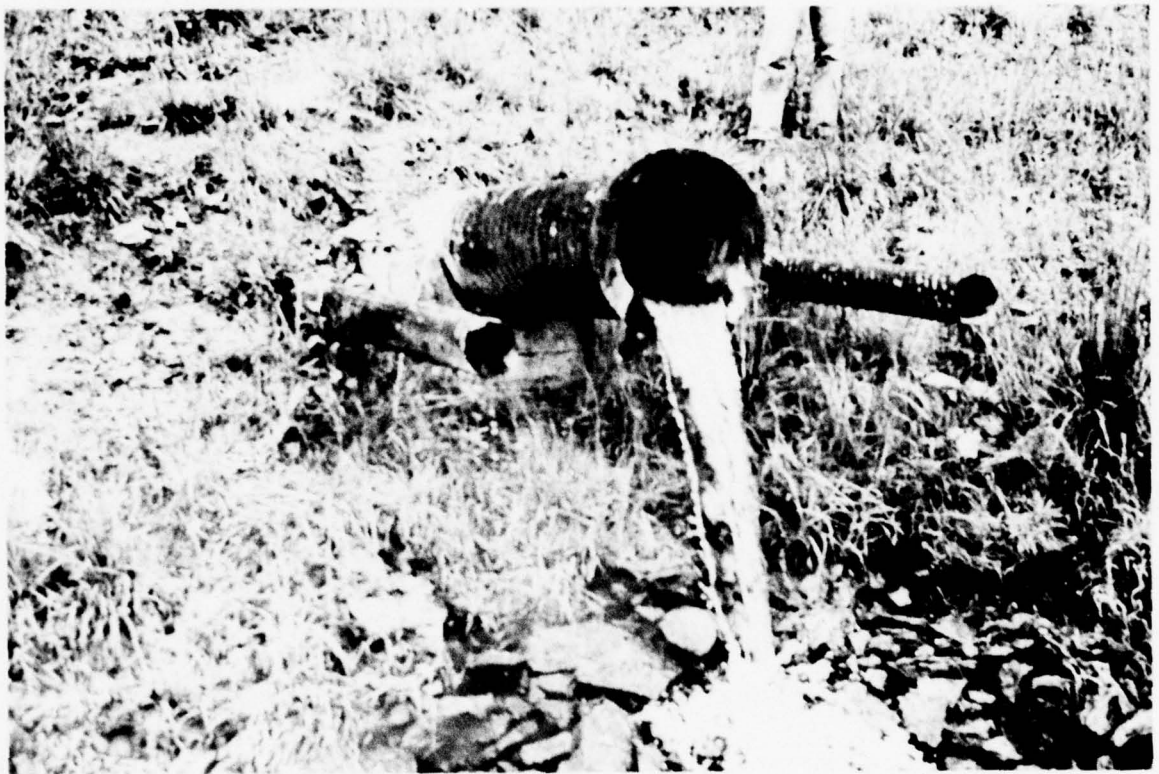
CLOSE-UP 18" PRINCIPAL SPILLWAY PIPE AND TOE DRAIN PIPES

1.7 Seepage: Wet areas present beside and beneath the principal spillway were covered with algae and moss.. Seepage existed along the base of the downstream toe of the right abutment and two seeps occur about 40 ft to the right of the intersection of the right abutment and the face of the dam. Flow was clear and generally less than 2 gpm. Minor iron-staining was encountered at a few locations, roughly midway between the seeps and the principal spillway. R. W. Gent stated that these seeps are actually springs, which were present prior to construction of the dam. He further stated that seepage under and through the dam had once been a problem, however a grout curtain installed several years ago by Cunningham Core Drilling and Grouting Corporation (Salem, Virginia) corrected this. None of the wet areas or seeps appeared to represent water passing under or through the embankment.

- 2.1 Outlet Conduit: 18 inch CMP coated with asphalt.  
No cracking or spalling observed.
- 2.2 Intake Structure: 24 inch CMP stand pipe.
- 2.3 Outlet Structure: 18 inch CMP coated with asphalt.

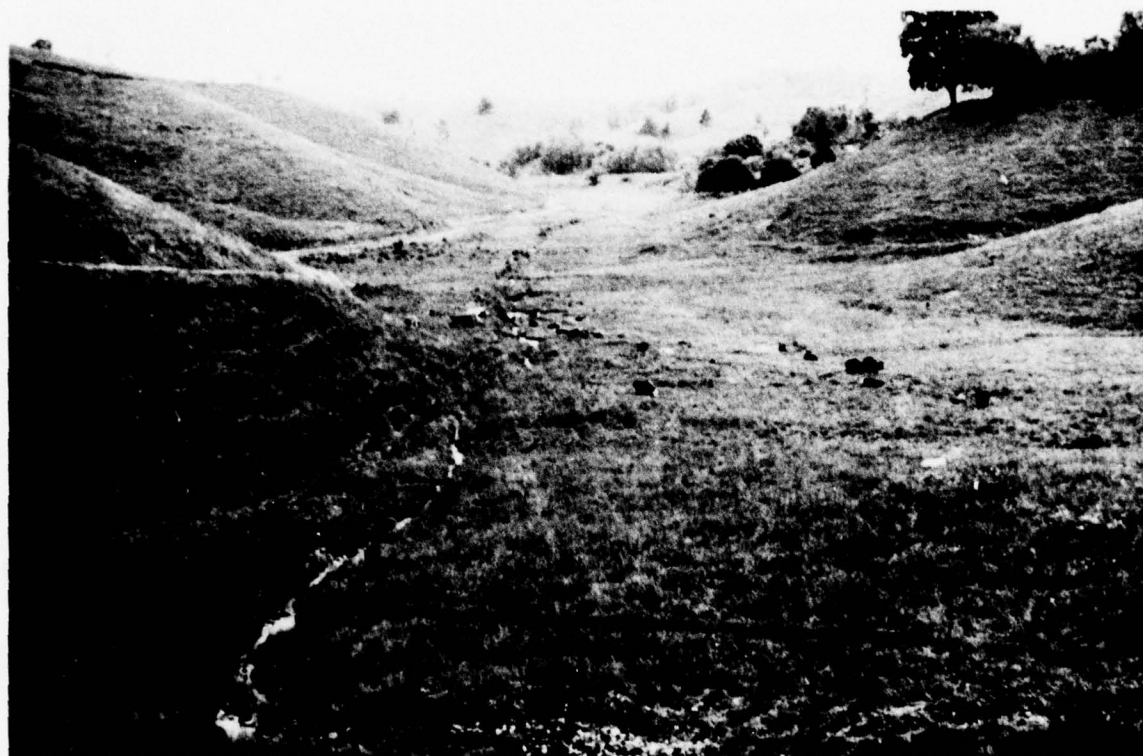
3.1.4 Downstream Area: The downstream channel showed no erosion or debris collection. The channel is 10 ft<sup>±</sup> wide and 2 ft<sup>±</sup> deep. Moderately steep to steep, grassed, natural slopes bound the stream. No sloughing or erosion was observed. A grassed floodplain several hundred ft wide exists below the impoundment. One home was observed approximately one mile downstream, and Va. Route 80 is about 1 1/4 mile downstream. A few homes and industrial developments are located near the intersection of Va. Route 80 and Va. Route 640.

VIEW OF DOWNSTREAM CHANNEL AND FLOODPLAIN
